Manhole Inspection Summary

Manhole # S65O__012MH

Insp Date: **4/23/08 2:25 PM**

Location Address: **1300 Bonsal St.**

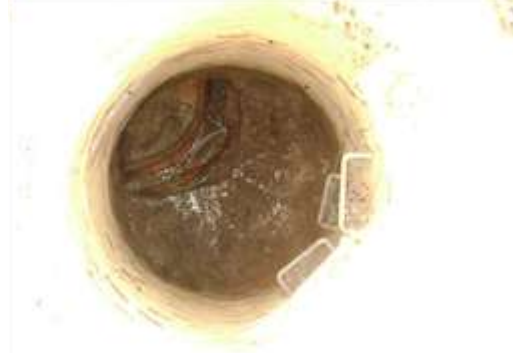
Top View

Comments **HEAVY MINERALS ENCRUSTED AROUND O12**

Condition: ☐ Sound ☐ Cracked ☐ Root Intrusion ☒ **Loose Brick** ☐ Deteriorated

Infiltration: ☐ None ☒ **Joint** ☐ Cracks ☐ Mortar ☐ Roots ☐ Wall
